Root Cause Failure Analysis of Stator Winding Insulation failure on 6.2 MW hydropower generator

Agus Adhi Nugroho¹, Ida Widiastuti², As Ary³

³PT. Indonesia Power UP Mrica

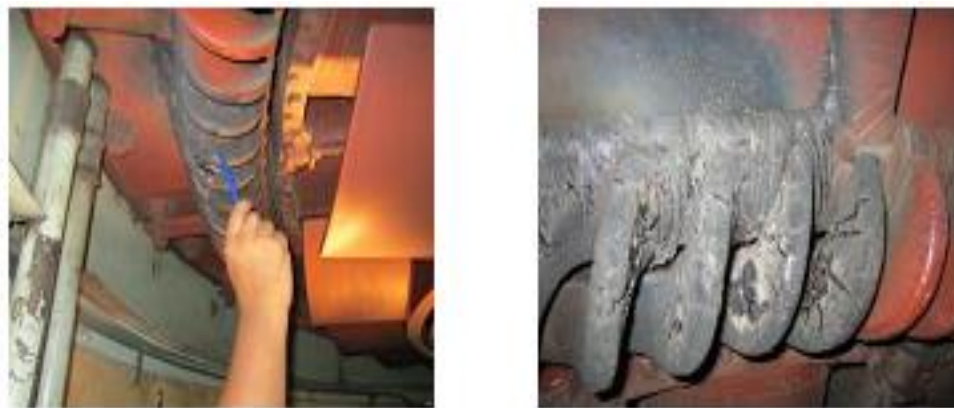
Winding failure 5 in stator coil insulation caused by the indication of partial discharge on the winding end side or bottom of generator stator. Visually visible damage on the upper side of the coil and bottom coil side of the upper winding phase -W does not appear abnormal. At the bottom of the winding phase –W, dark and white colors indicate short at the stator body as shown in Figure 1.

Figure 1. Short circuit W-phase stator generator

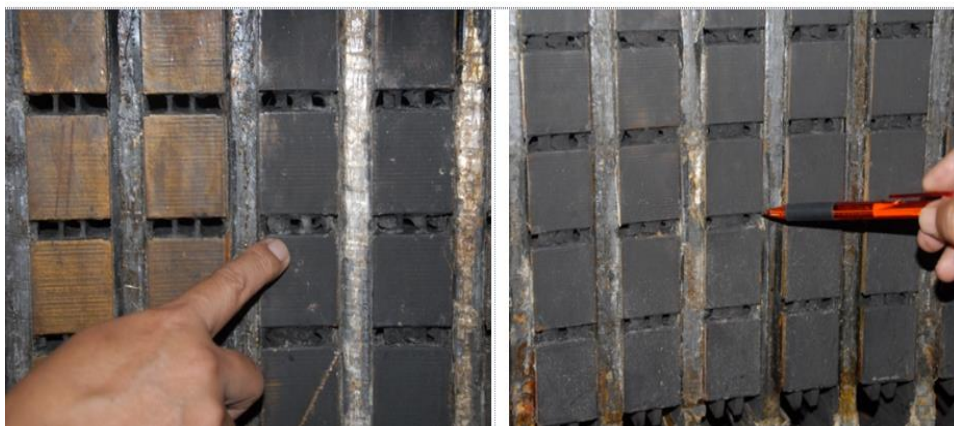
Indications of oil and dust deposits on the coil accumulated for a long time in the area shows that the generator stator air quality at generator stator cooling system has poor quality. This evidence is shown by the photo after the pull-out rotor in Figure 2.

Figure 2. Grid dirty obstruct the flow of cooling air

Figure 2 shows the evidence that by the discharge air temperature over the limit of maximum standards of 55 degree Celsius. Cooling system in hydropower generator stator Wonogiri is not optimal due to the accumulation of dirt, grease, and dust. The accumulation of dirt impedes the flow of air so that surface temperature at different winding is inhomogeneous and it arises a local thermal stress and triggers partial discharge. suspected that the partial discharge already occurs for long duration and cumulates since the last maintenance in 1994 or 18 years ago.

Generator maintenance is important to be applied for every 50000 to 60000 hours of operation or 5 years in order to anticipate the occurrence of insulation failure at generator stator winding.
